Micro-Monitoring:

An innovation in monitoring
low flows in sanitary sewers

Gerard J. Fernandes, PE

Stantec Consulting Services, Inc.

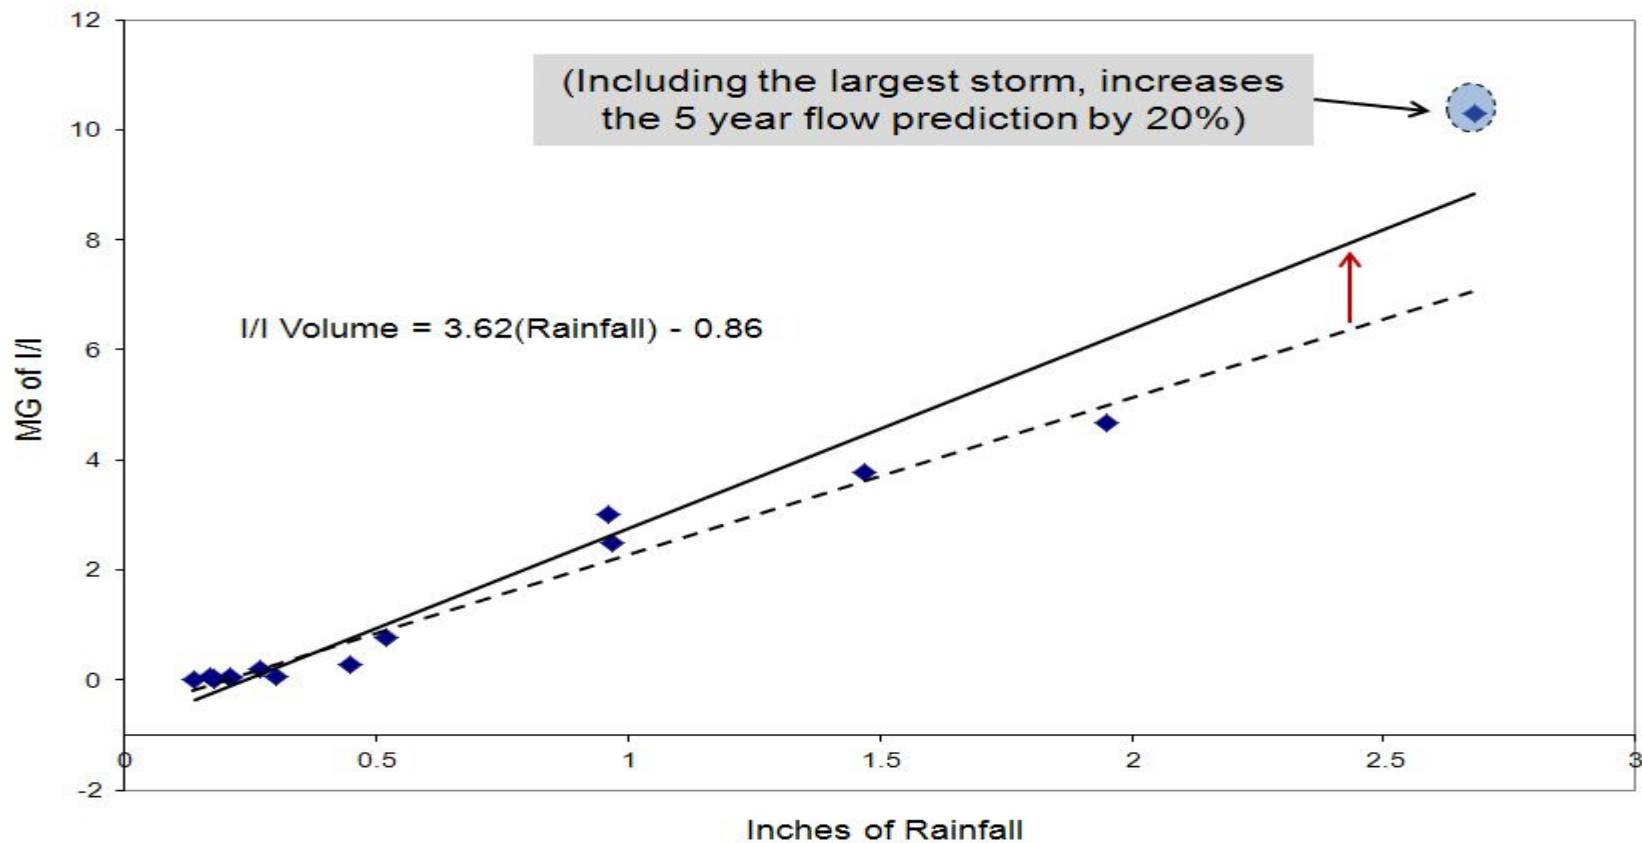
How Many Storms Do You Need to Quantify I/I?

For the Modeler?

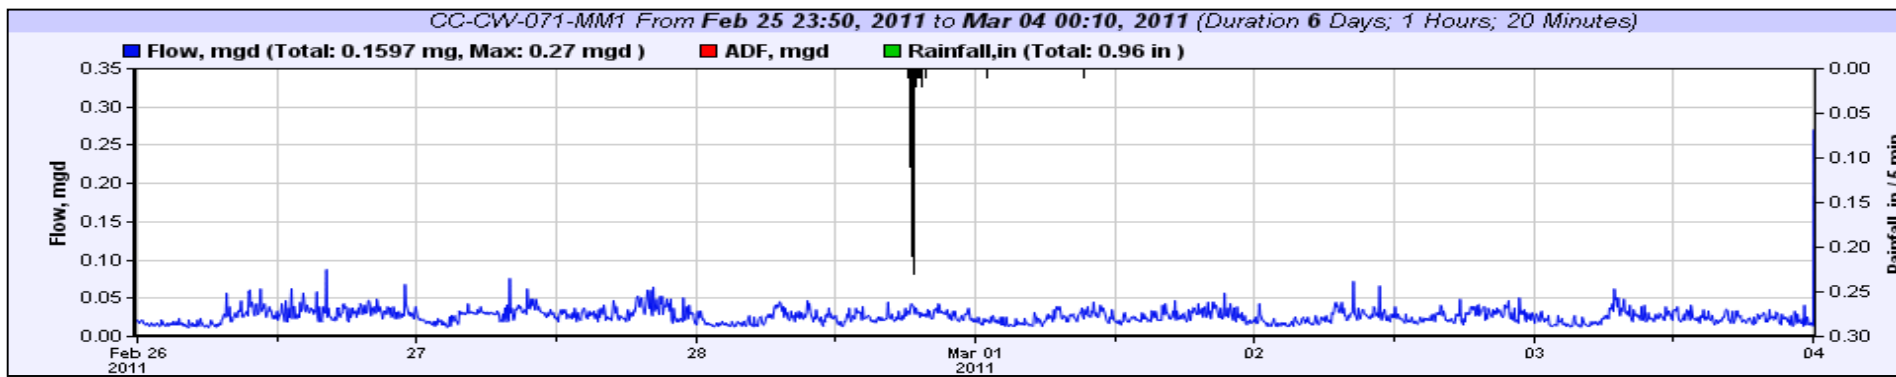
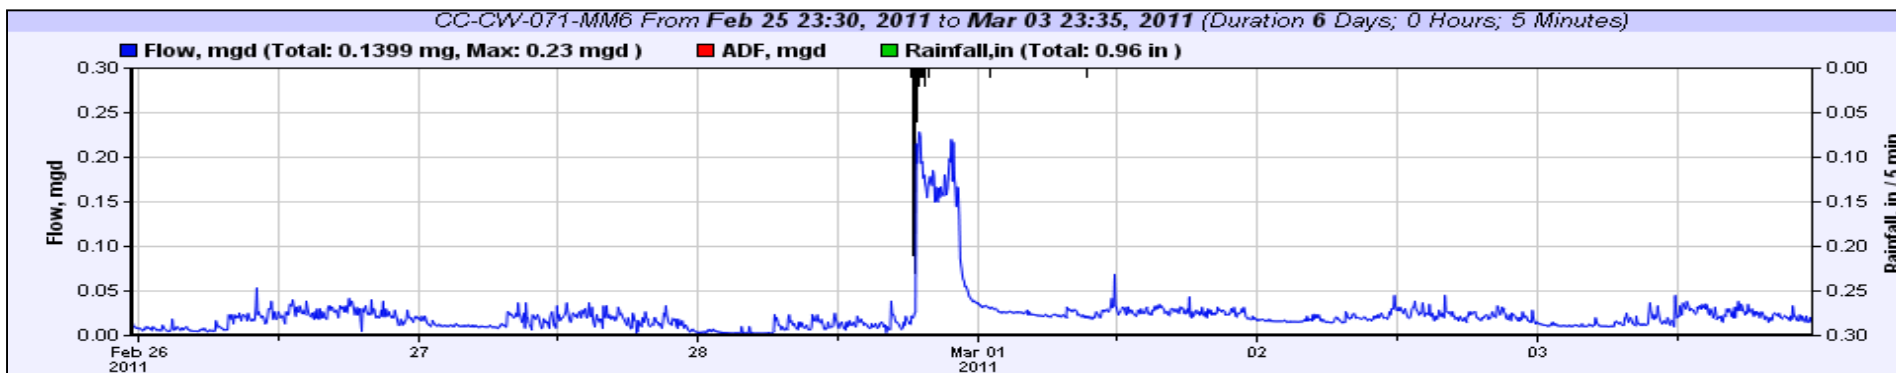
For the I/I guy?

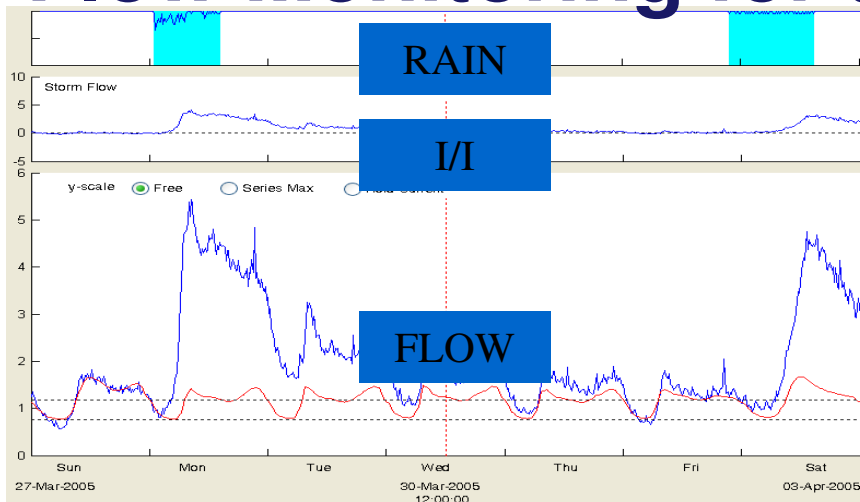
Flow Monitoring for the Modeler

Regional Monitors
(1 per 6 miles of pipe)

How do you distribute the I/I to the upstream pipes?

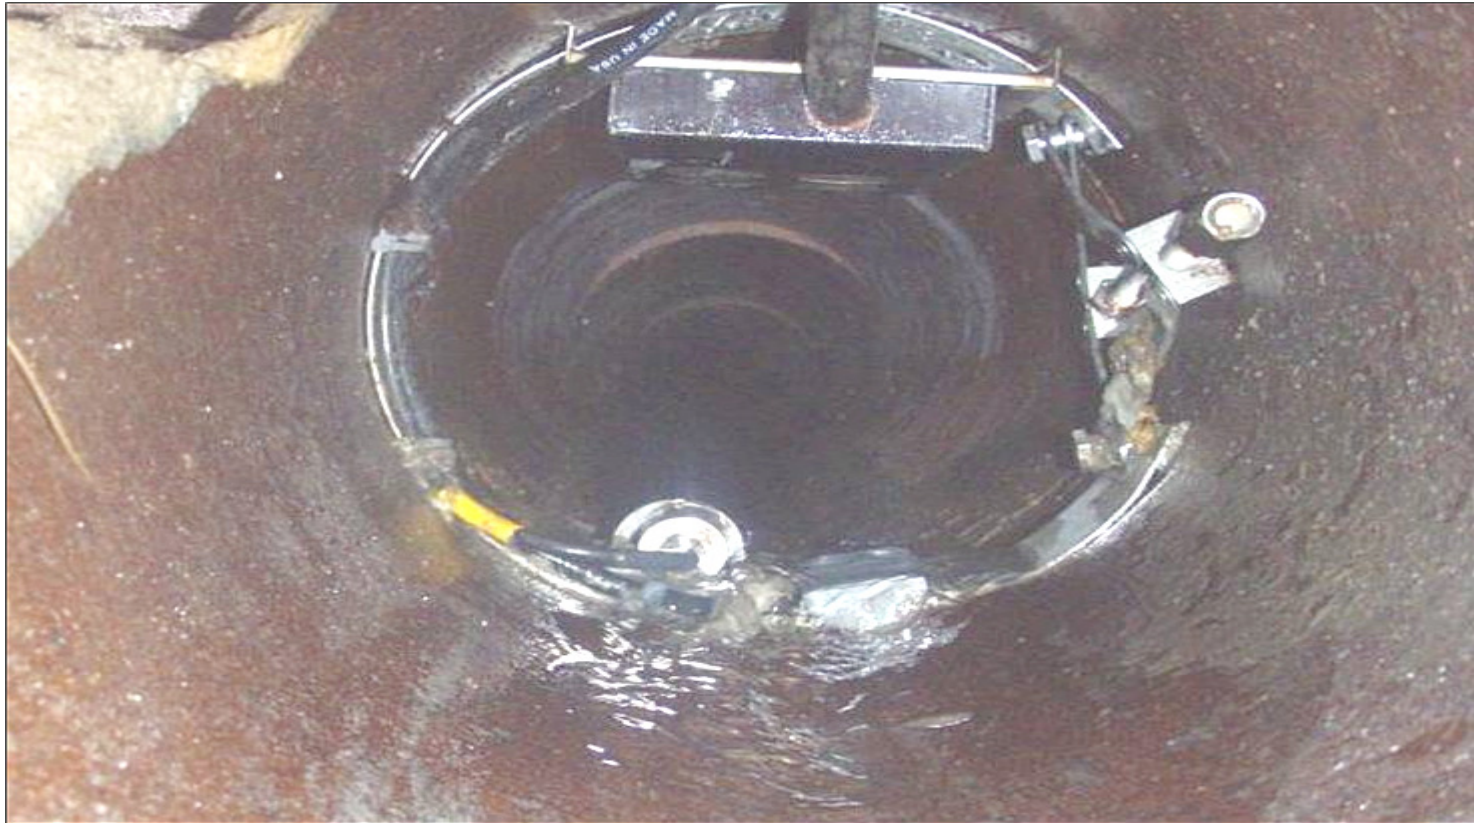
What is the Problem with Low Flow?

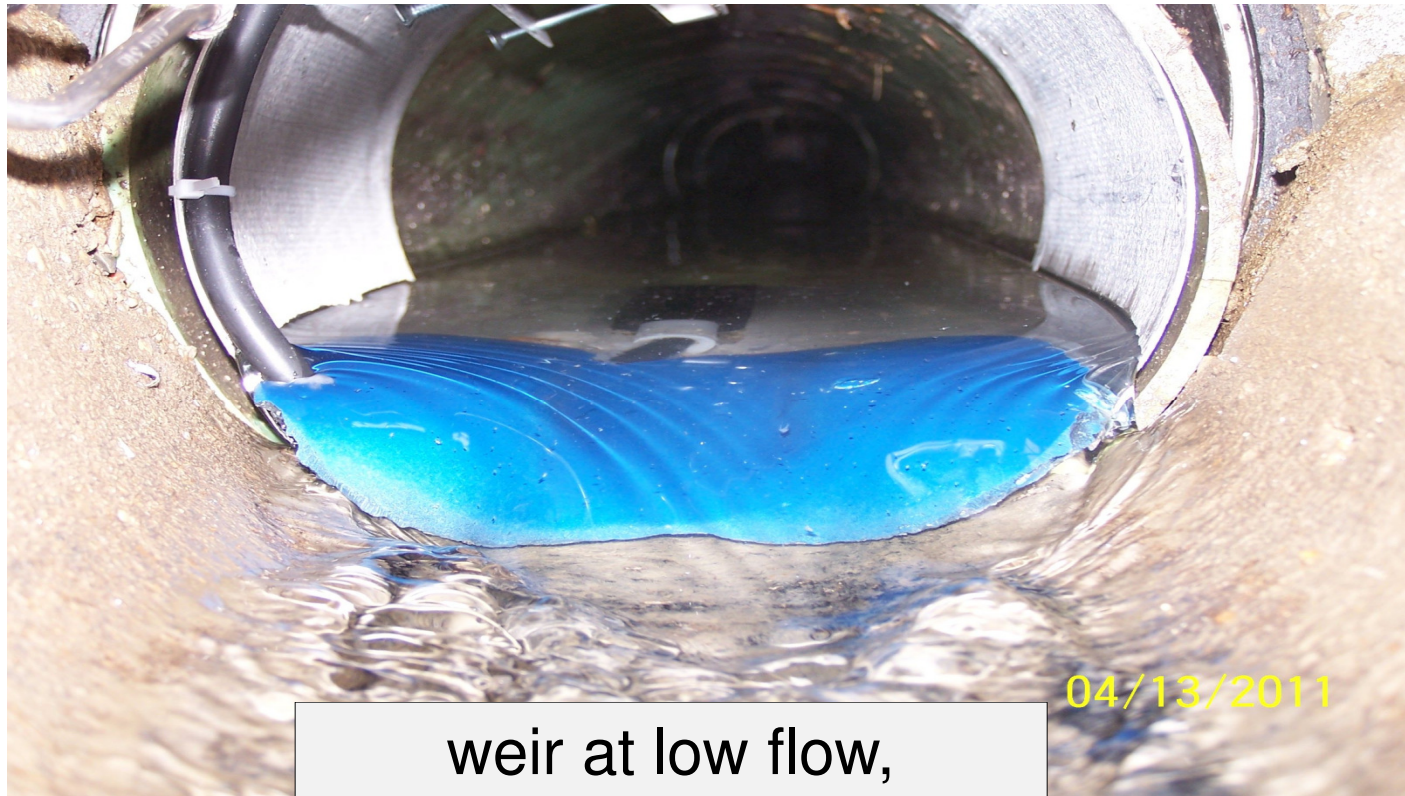
What is a Micromonitor?

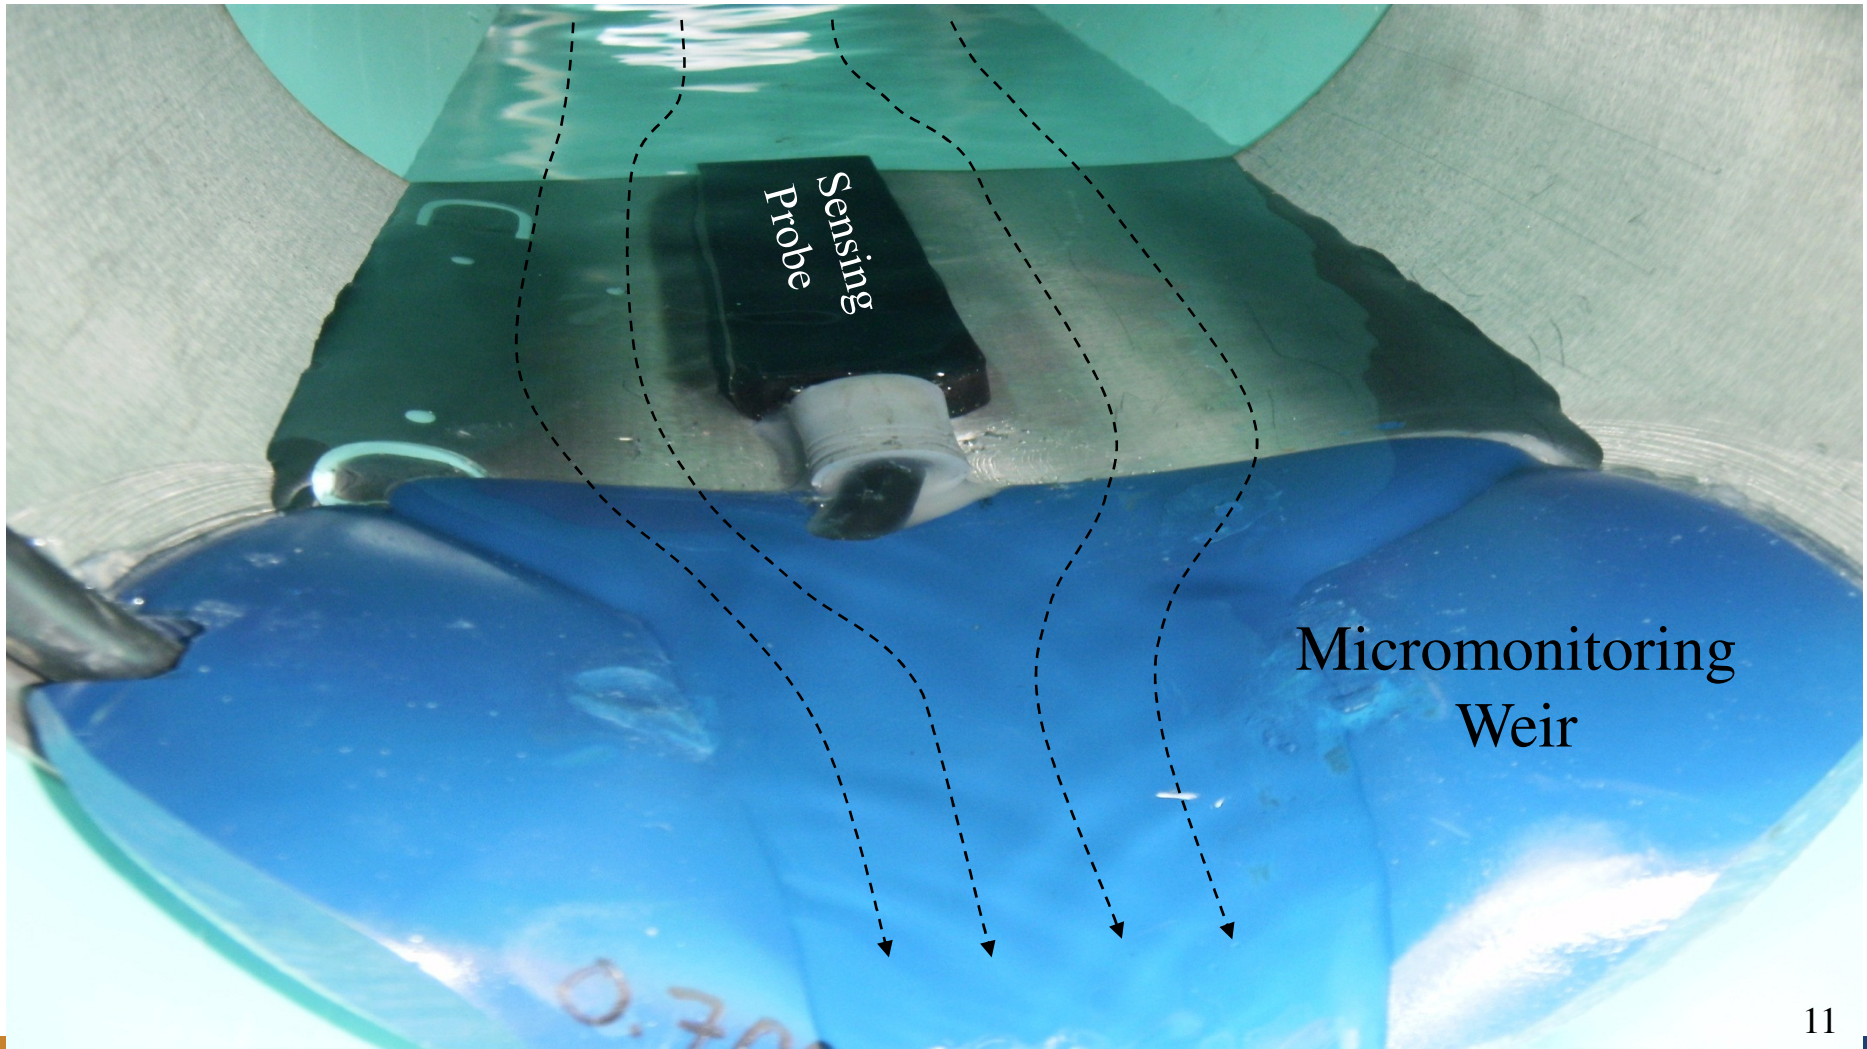
weir at low flow,
area-velocity at high flow

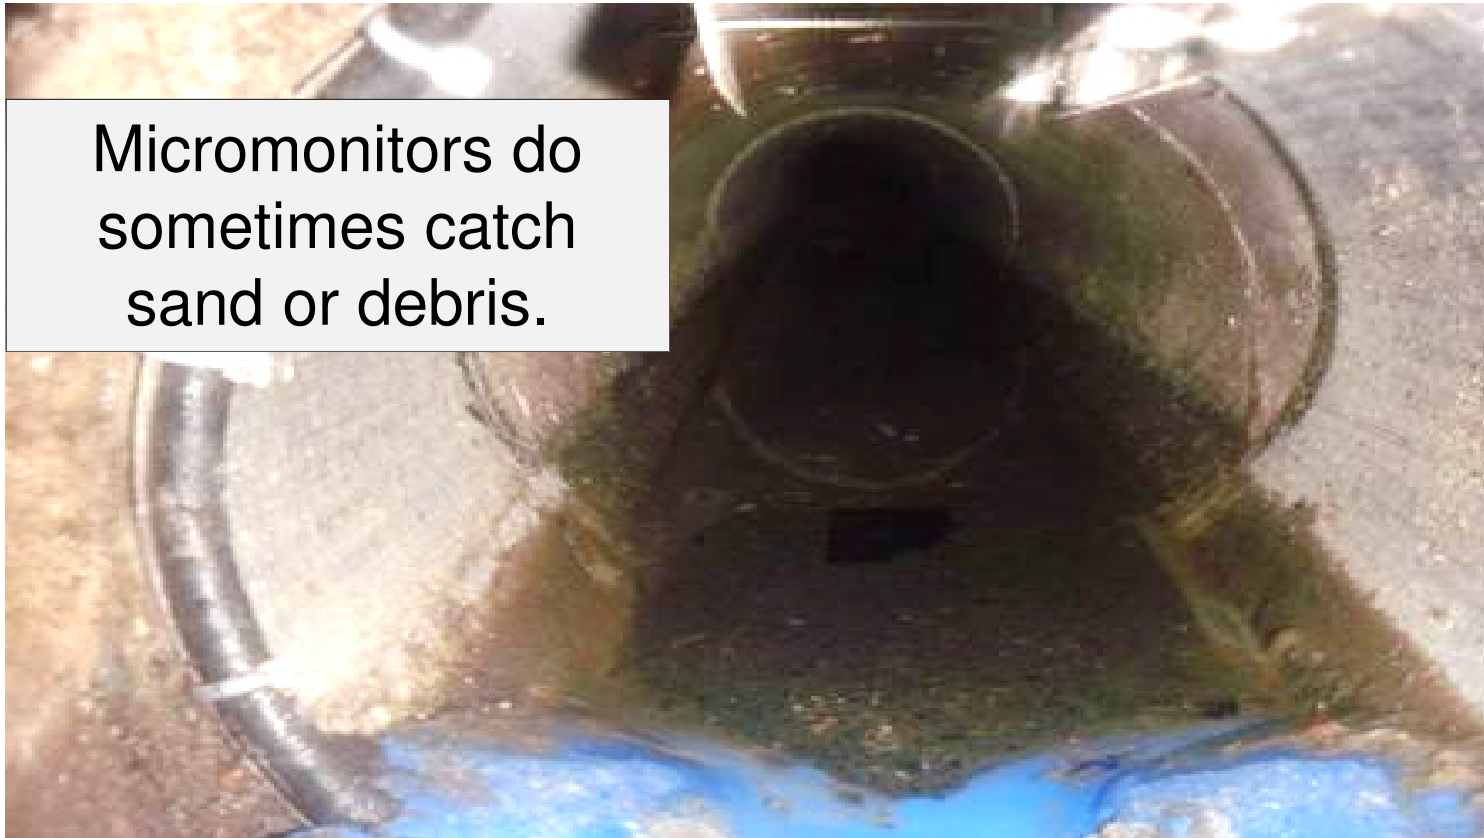
Micromonitors do
sometimes catch
sand or debris.

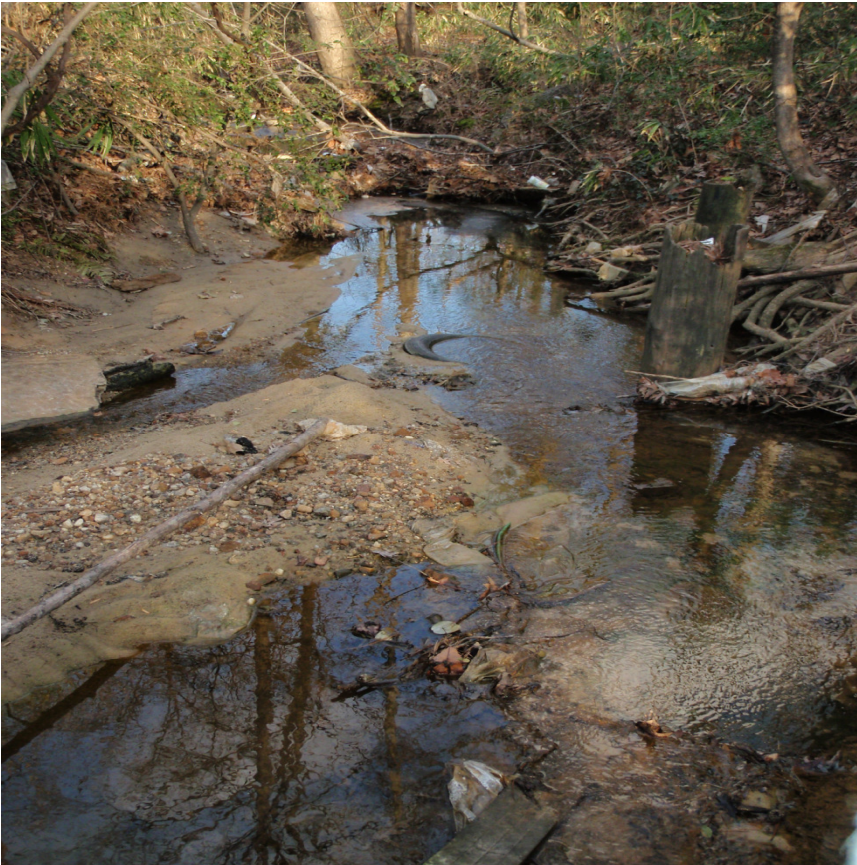
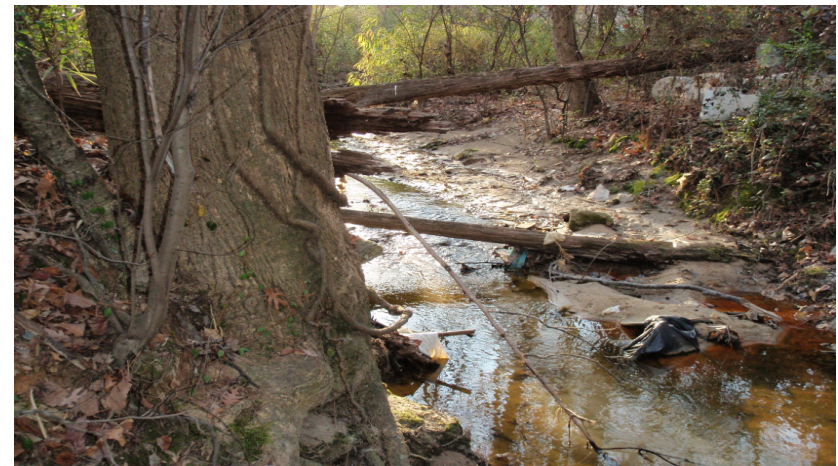
MM-04

MM4 Upstream Area is one of the only areas in the project area below the stream level, and it is all sand.

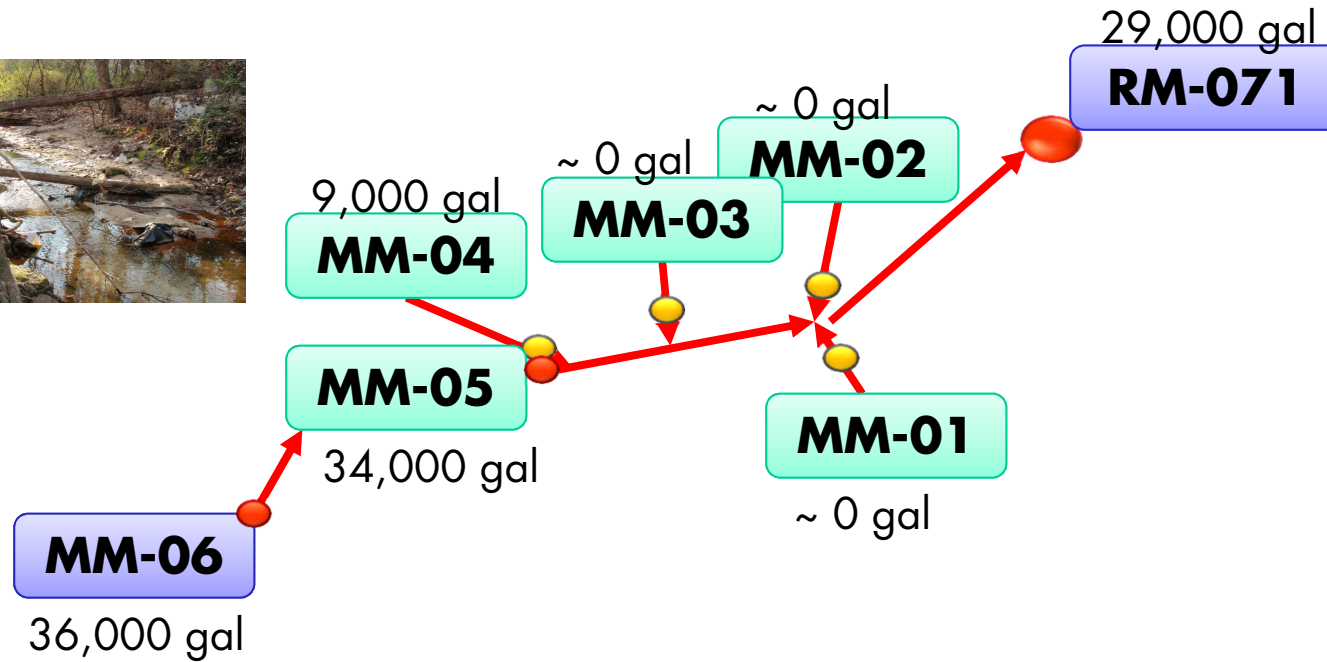
CCWA Flow Schematic

and Micromonitoring flows for the February 28th Storm

MM-06 goes through MM-05 and RM-071, so the I/I generated at MM-06 is seen in all three graphs!

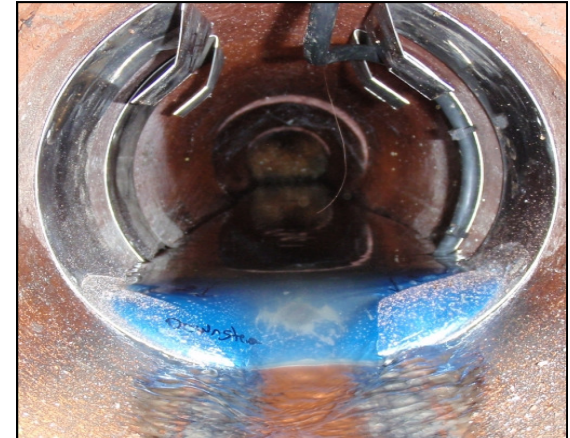
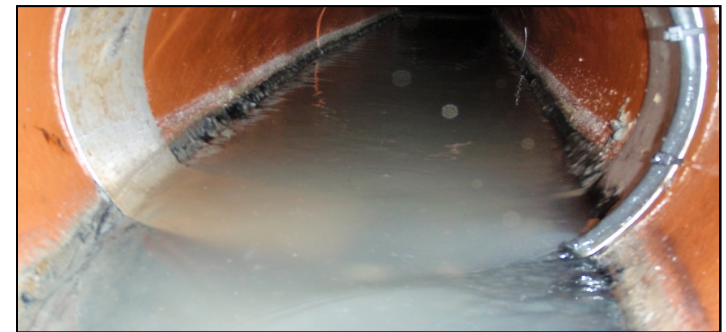
CCWA Case Study - Summary

INFLOW: In the intense Feb 28th Storm, almost all of the inflow recorded at the downstream monitor **071**) originated in **Sub-basin 6**.

18% of the Basin

All remaining sub-basins show no

measurable direct inflow

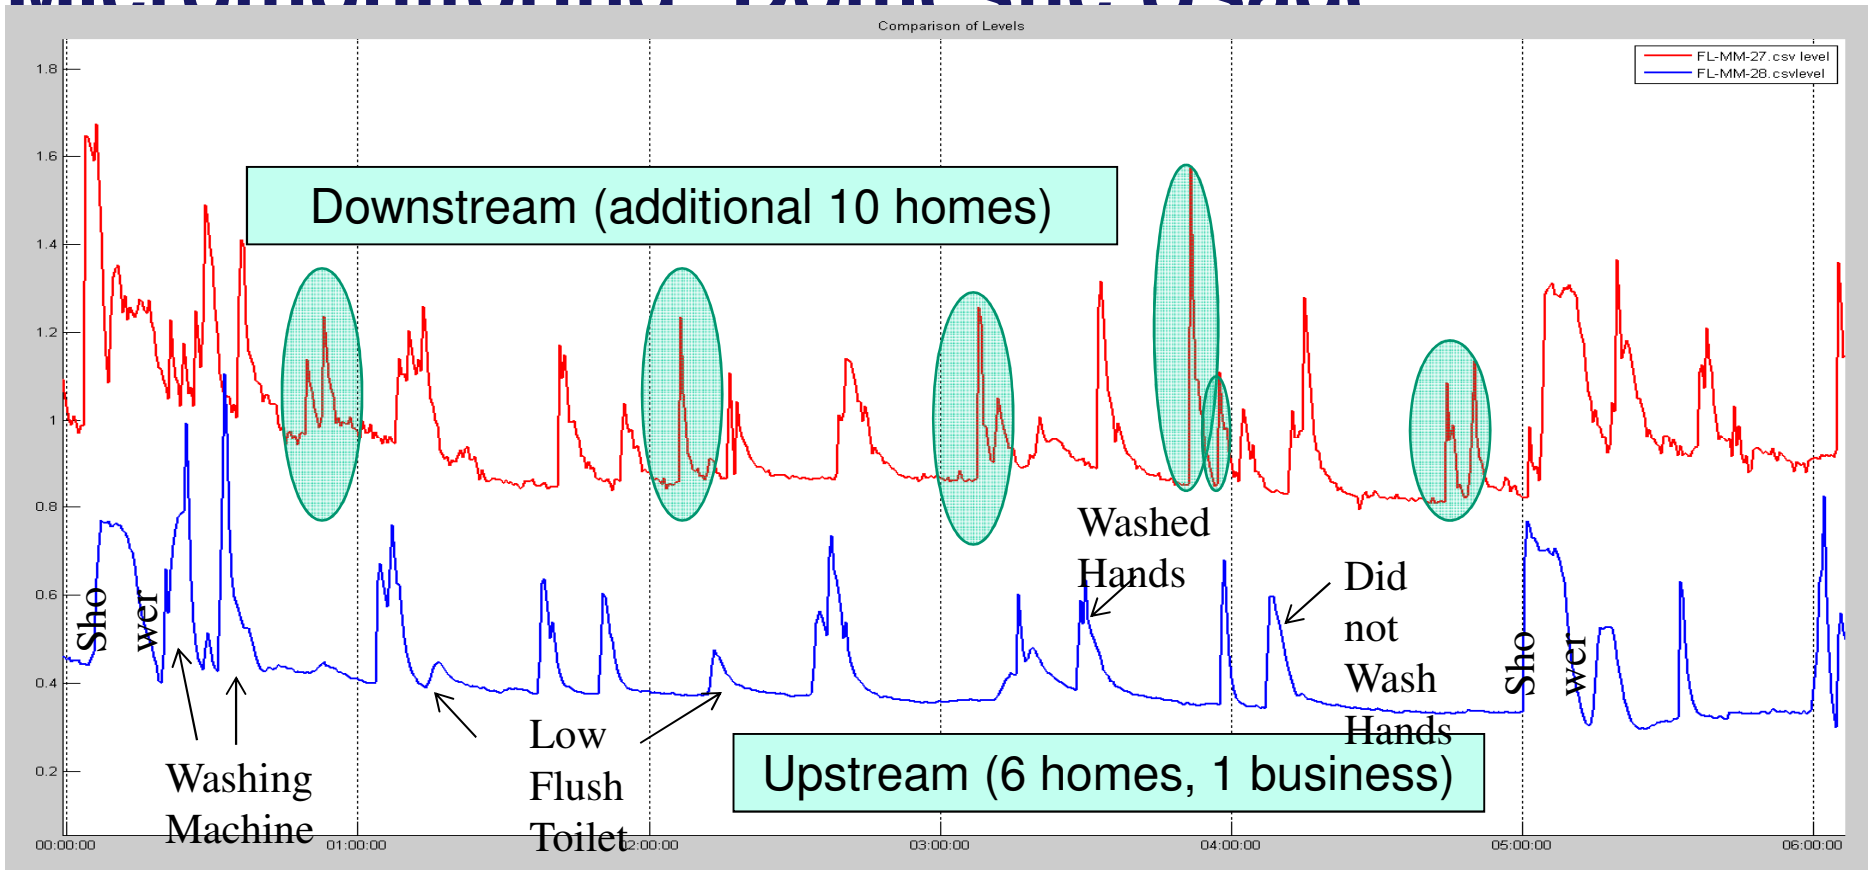
Micromonitoring - Domestic Usage

30 second level data, Adjacent manholes.

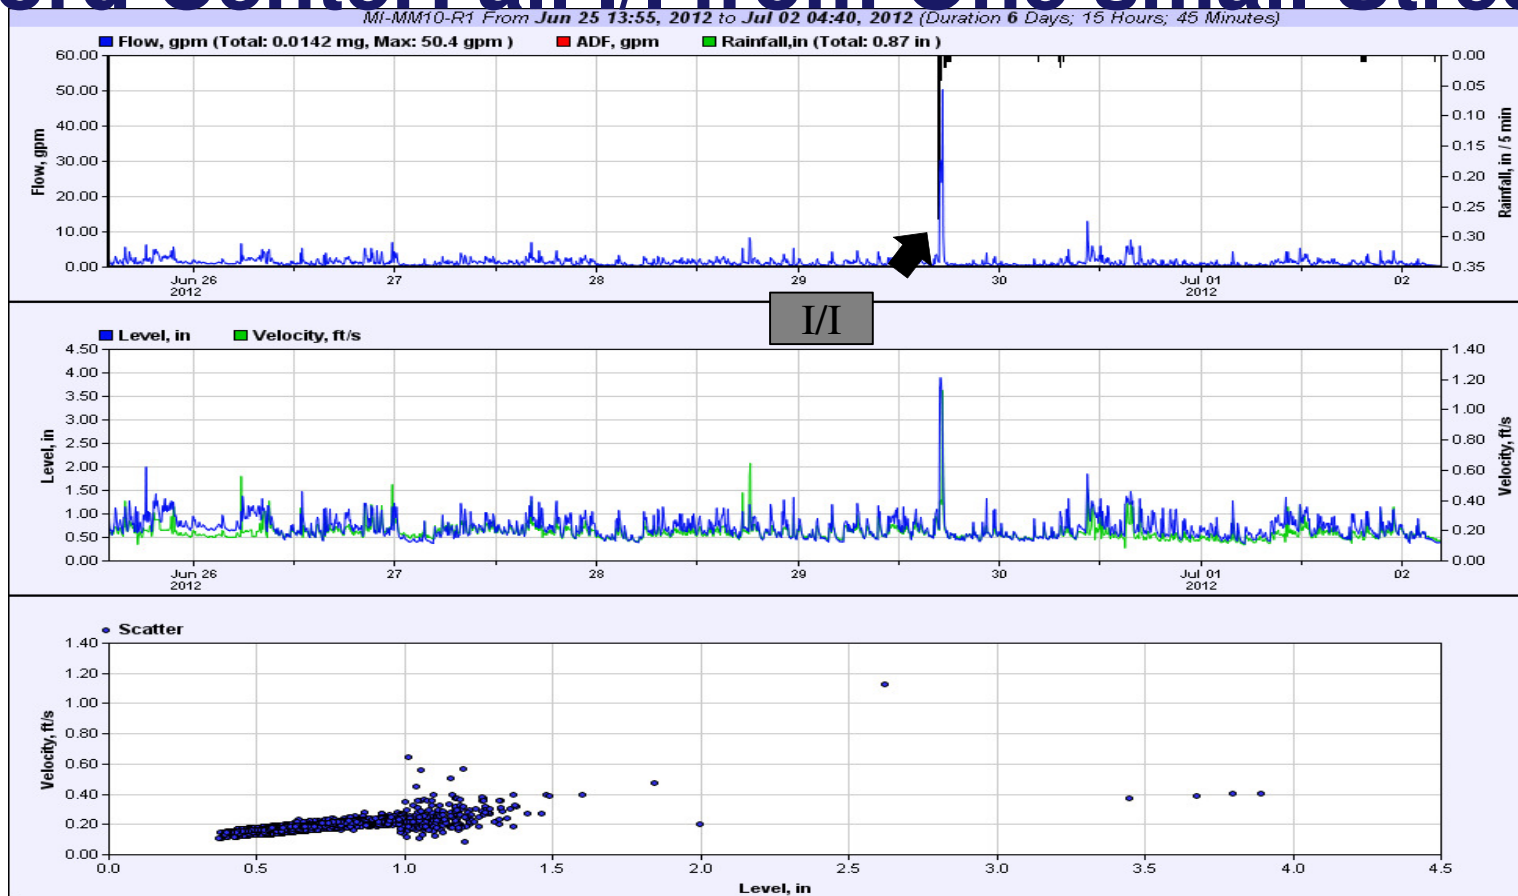
Milford Center: all I/I from One small Street

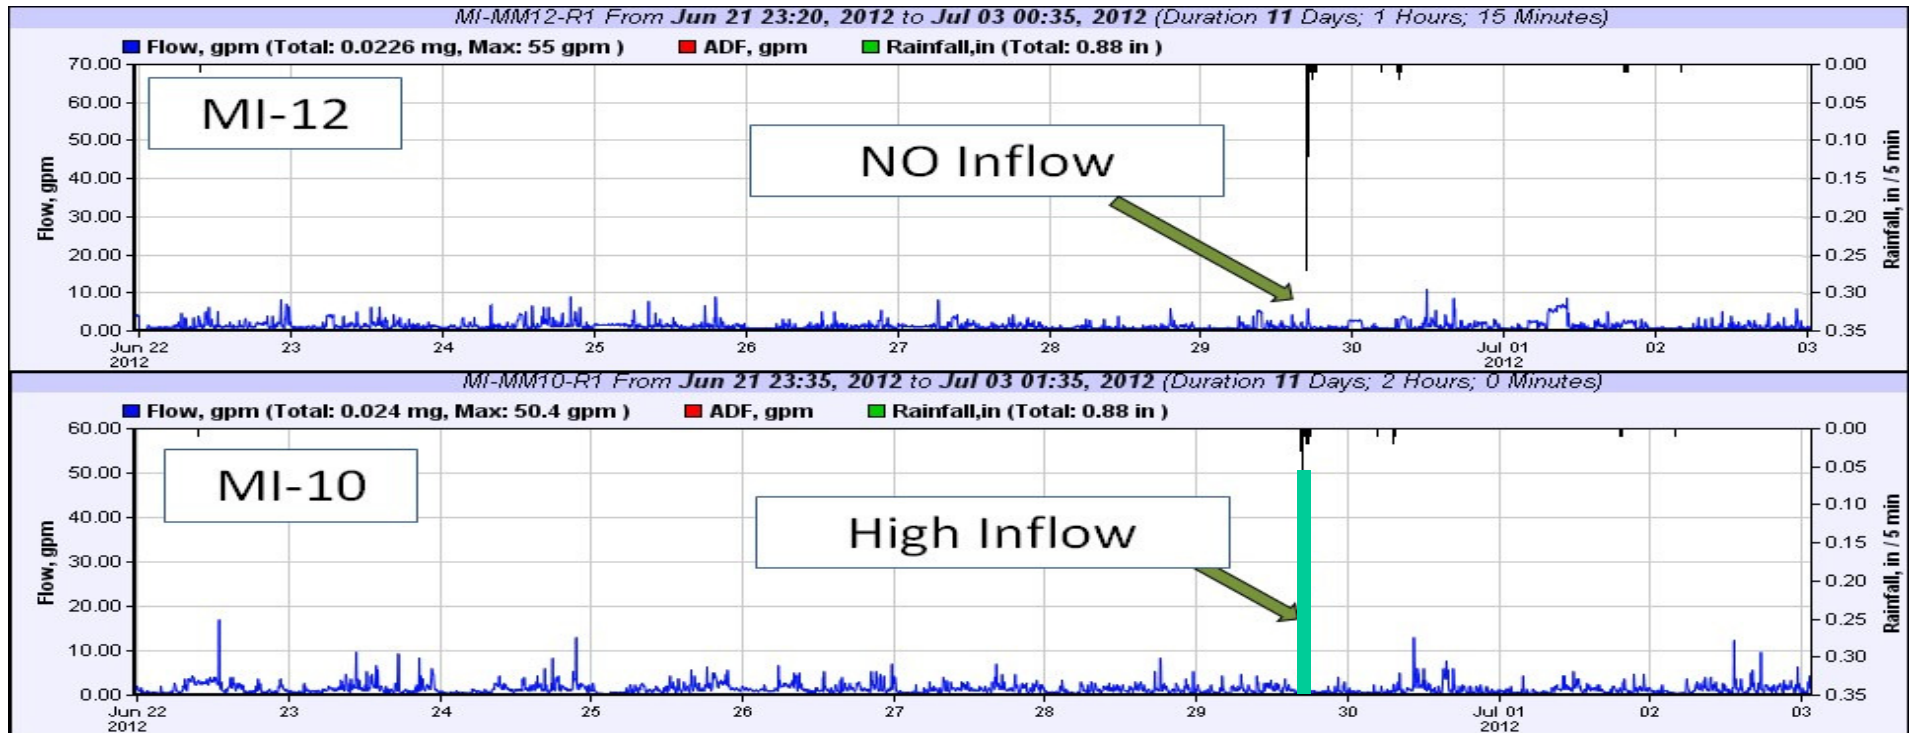
Milford Center: all I/I from One small Street

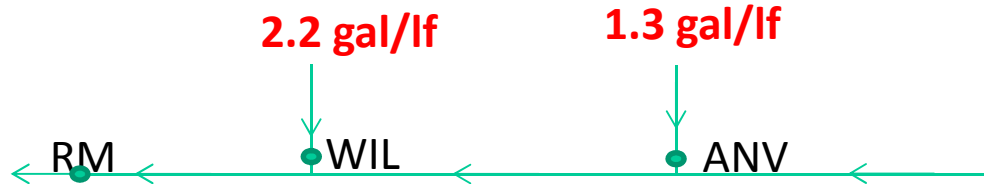
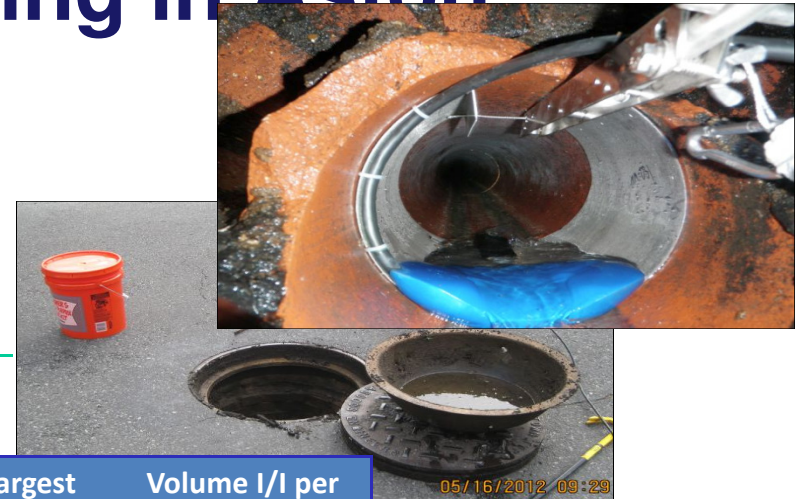
SWDCMA Micromonitoring in Aston

I/I volume during June 13, 2012 storm,
0.15 inch storm

Length of Upstream Pipe (LF)	Percentage of Total Pipe in Basin	Volume I/I in Largest Storm (gal)	Volume I/I per LF of Pipe (gal/ft)
RM (total)	5,909	100%	4,047 *	0.68*
Subbasin flow	2,800	47%	Net negative	Net Negative
Williams Drive	1,306	22%	2,811	2.2
Anvil Road	1,803	31%	2,440	1.3

* Appears to be underestimated. Stantec did not operate this meter

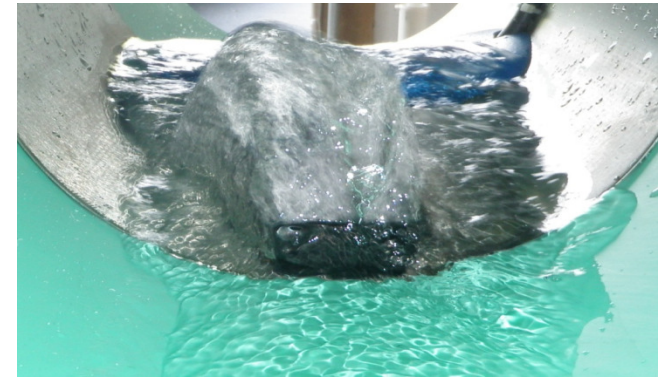
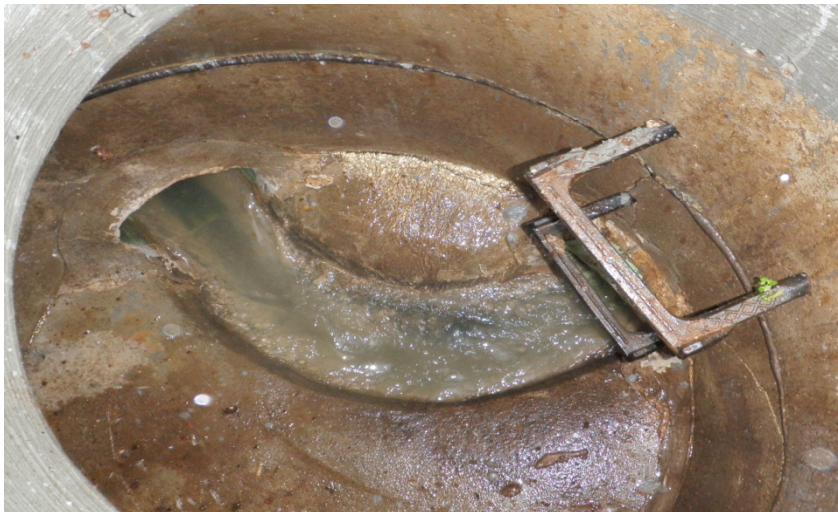
Micromonitoring: Limitations

Current sizes are 6, 7, 8 and 10" pipes

Overestimates during surcharge and steep pipes

Difficult to install with curved fillet
